The
San Francisco Earthquake and Fire

A BRIEF HISTORY OF THE DISASTER

A. L. A. HIMMELWRIGHT, C.E.

THE ROEBLING CONSTRUCTION COMPANY
FULLER BUILDING, NEW YORK, N. Y.

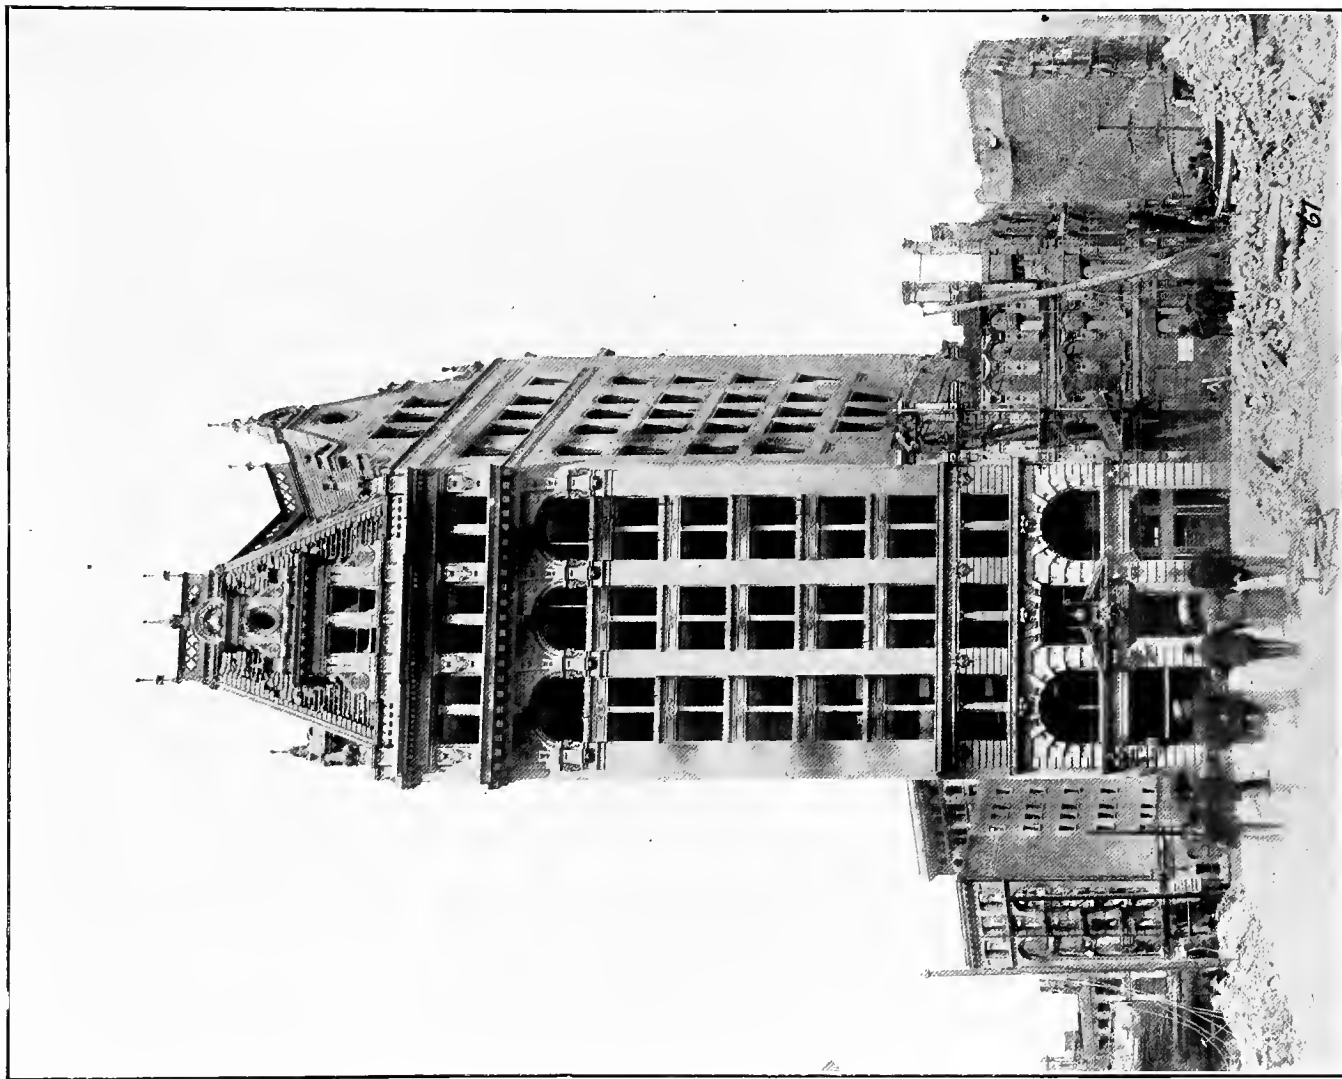
The Geary Street front is very badly spalled and scaled by the fire and must be wholly renewed. The Kearny Street side is comparatively little damaged. The Market Street front is slightly spalled in the three lower stories. This can probably be repaired. The upper stories and the Kearny Street side can be restored by cleaning and slight repairs. The roof tiles, which were attached to T framing at 18" centres, are badly damaged. Many of the tiles are broken and 40 per cent. are moved more or less out of position. They were attached to the T's by wires which passed through a hole in a lug on the under side of the tile. Being fastened at one point only, they were readily shaken out of position by the earthquake, and many of the lugs were broken.

The levels on the water table show that the foundations remain practically level, the S. E. corner being about ⅜" lower than the other three corners. The greatest observed variation from the plumb of the walls is ¾" to the south at the S. W. corner and ⅝" to the north at the N. E. corner. These variations from the plumb are no more than are found in newly constructed buildings that have not been subjected to earthquakes.

MUTUAL SAVINGS BANK. Junction of Market, Geary and Kearny Streets. The façades consist of Raymond gray granite for the first story and Colusa sand stone above. This building is structurally uninjured. The foundations are level and the walls remain plumb. The greatest damage sustained by the exterior was on the Geary Street side, which must be wholly renewed, and the tile roof, large portions of which must be rebuilt. The other fronts of the building are but slightly damaged. The Roebling concrete floors and wire-lath ceilings throughout are uninjured. The column protection consisting of a double thickness of Roebling wire lath and plaster, with an air space between, is in first-class condition. All the wire-lath and plaster partitions remain standing, although deflected and buckled out of line in some places.

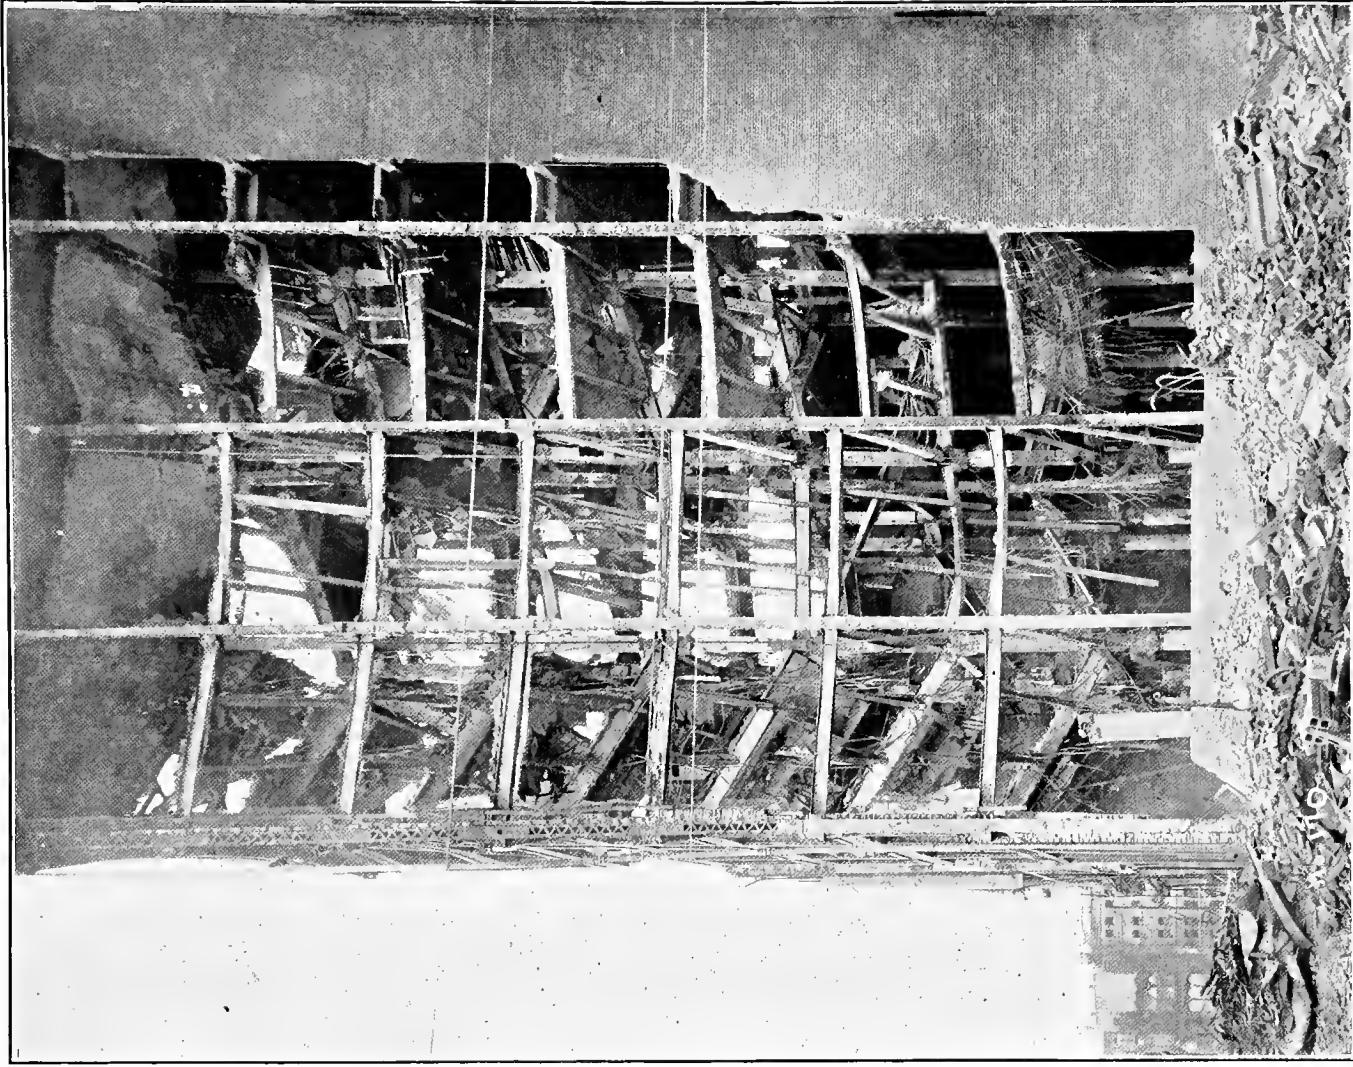
KAMM BUILDING. Showing the collapsed rear portion of the building caused by column failures in the basement. The tenacity of the connections of the wall girders at the columns is remarkable. Two beams framed to them, when carried downward in the centre, have twisted the girders in the middle section through an angle of about 80 degrees from the vertical. The Roebling concrete floors cling to the beams; seven tiers in the rear of the building being inclined at an angle of about 35 degrees, and other sections of the floors being warped and distorted into almost every conceivable shape. Note the curved skyline of the rear where the central columns have been drawn inward by the collapse.

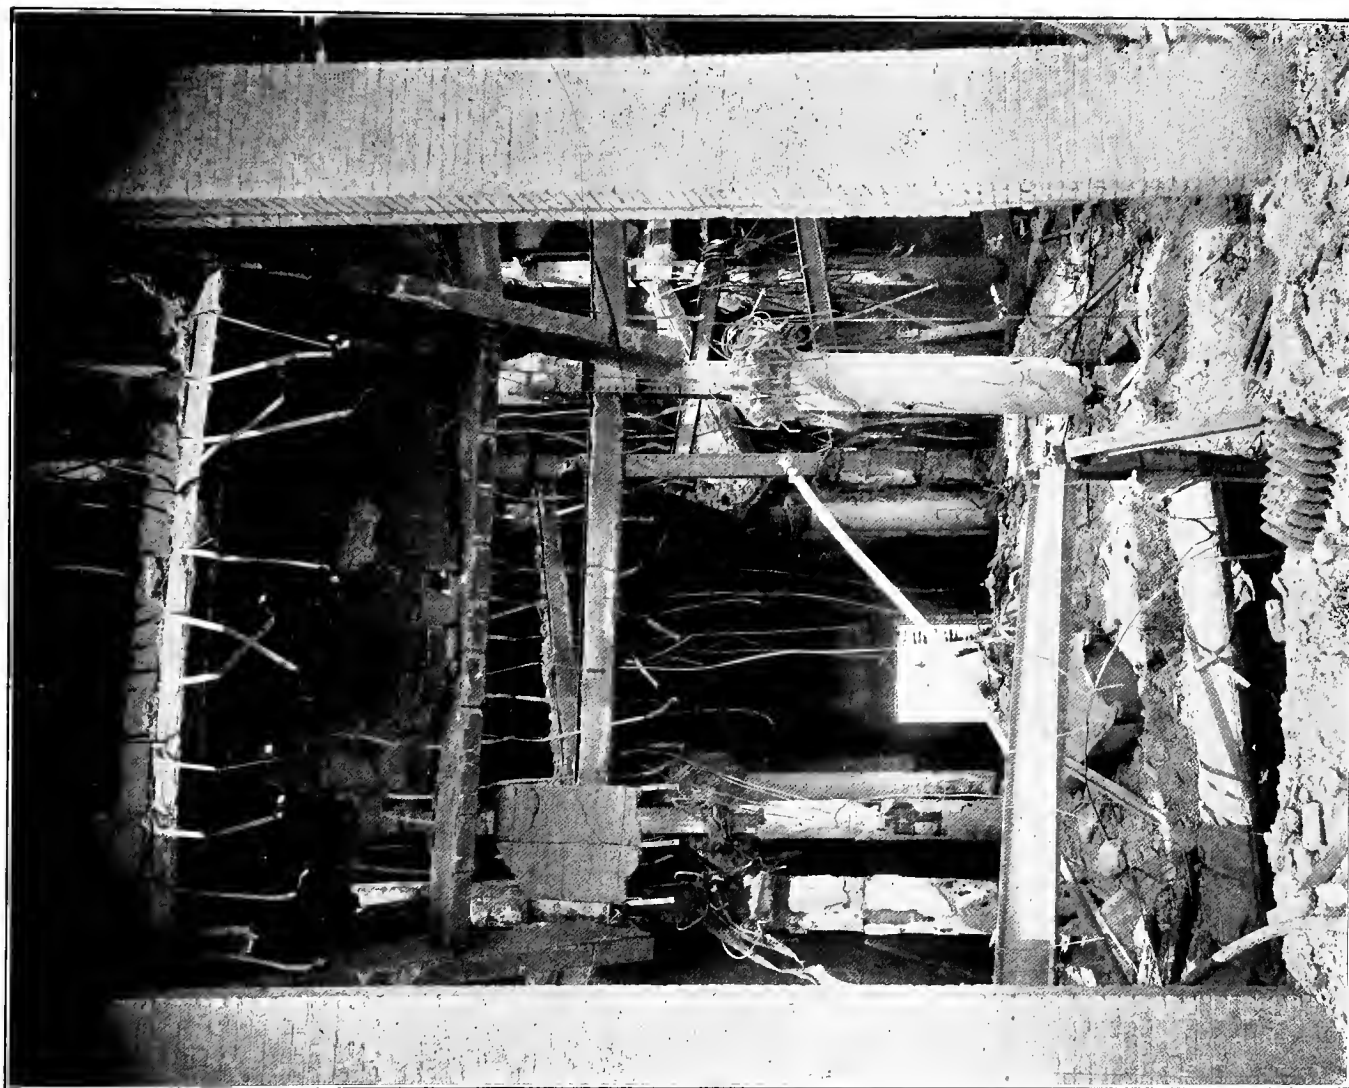
KAMM BUILDING. Looking into the wrecked rear portion from Stevenson Street. The basement of this building was used as a store-room for a wall-paper concern, and was filled solidly with stock. The heat from the burning of the wall-paper stock buckled the columns to the extent of 6 or 8 ft. of their length and wrecked the entire rear portion of the building. The fire in the basement was still burning on May 19th, when this building was inspected, a month after the origin of the conflagration. Note the concrete floor slabs, though cracked and badly injured, still clinging to the steel beams. The soffit protection of the beams is wonderfully tenacious.

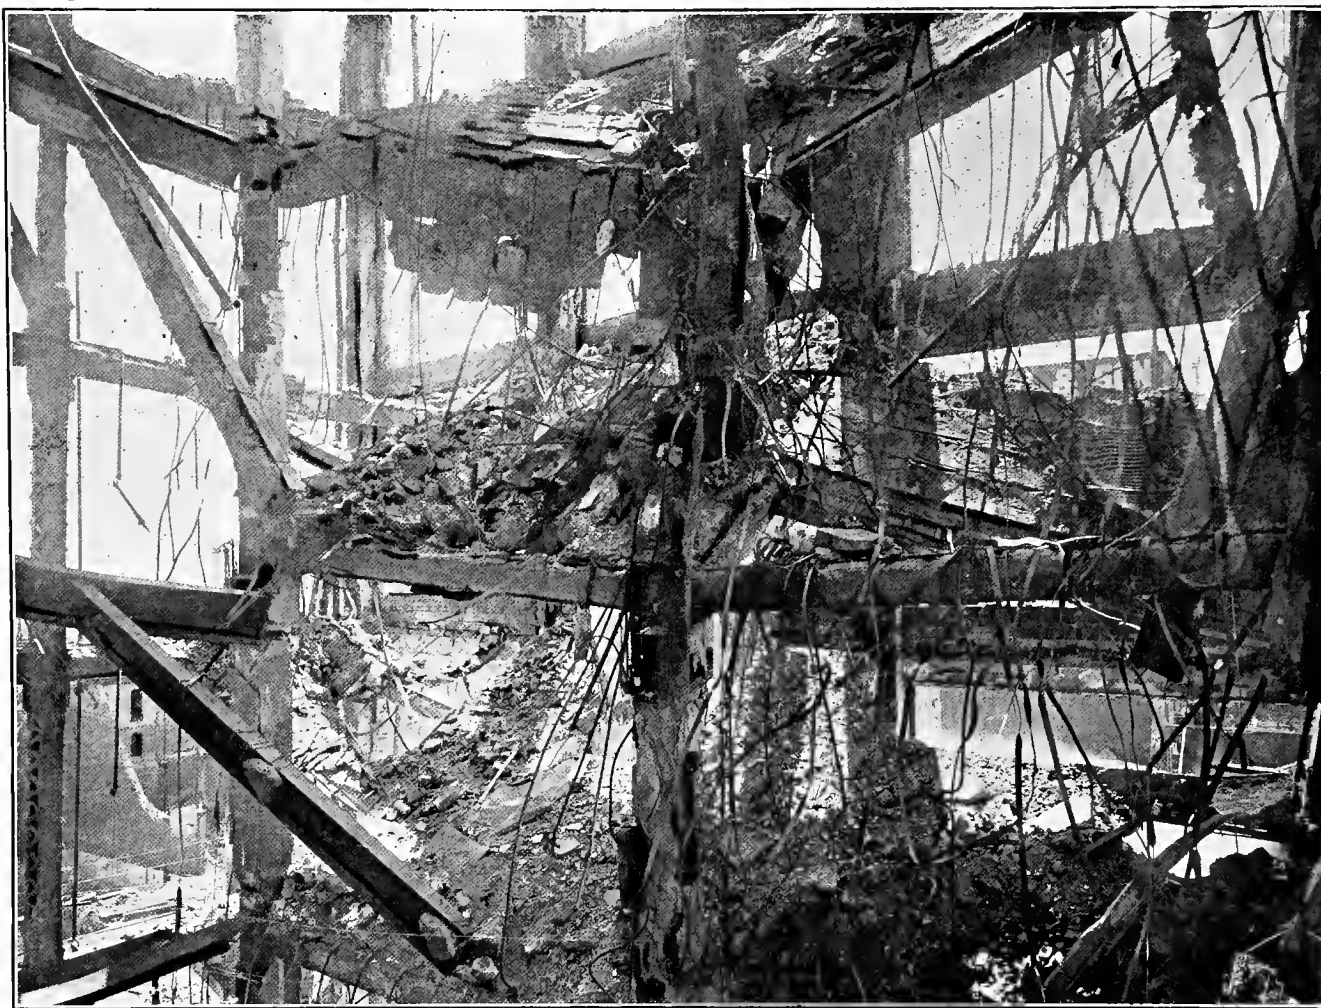
KAMM BUILDING. Seventh Story. Showing the rear collapsed portion of the building at this level, looking southeast. The water tank at the right fell from the roof and was held by a section of Roebling concrete flooring that was still supported by the steel work. Note the furring and lathing of the columns which still remains generally in place after the plaster has been jarred and stripped off by wreckage.

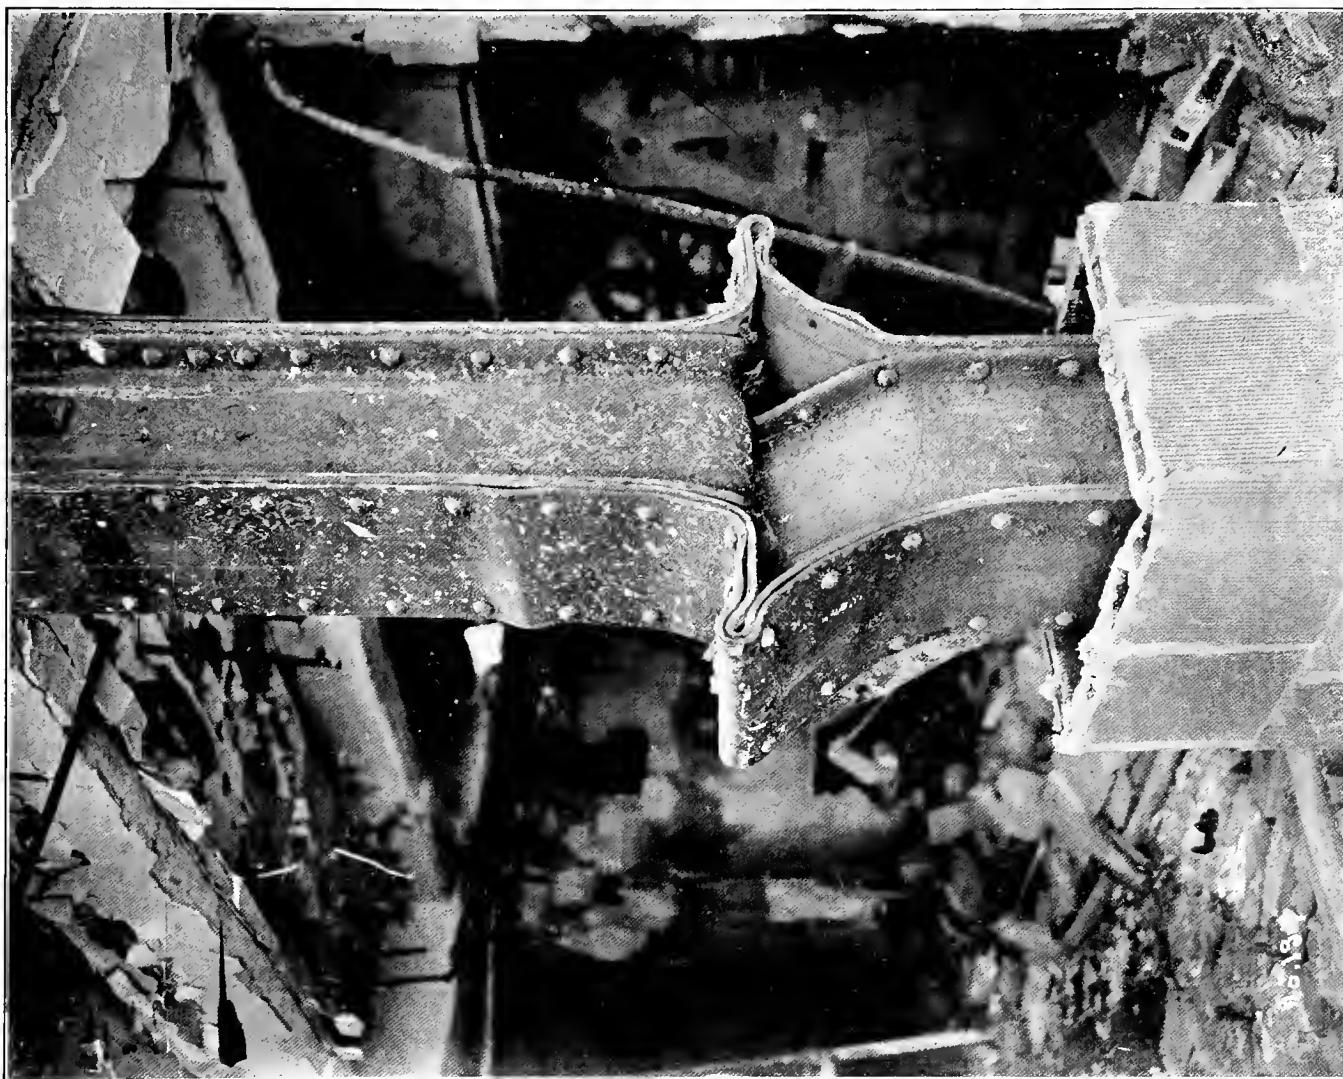
ARONSON BUILDING. Basement Story. The failure of the hollow tile column protection caused the column to buckle, letting down the floors above about two feet. The Roebeling concrete floors are in good condition. Note the soffit protection clinging to the girder in the upper right-hand corner.

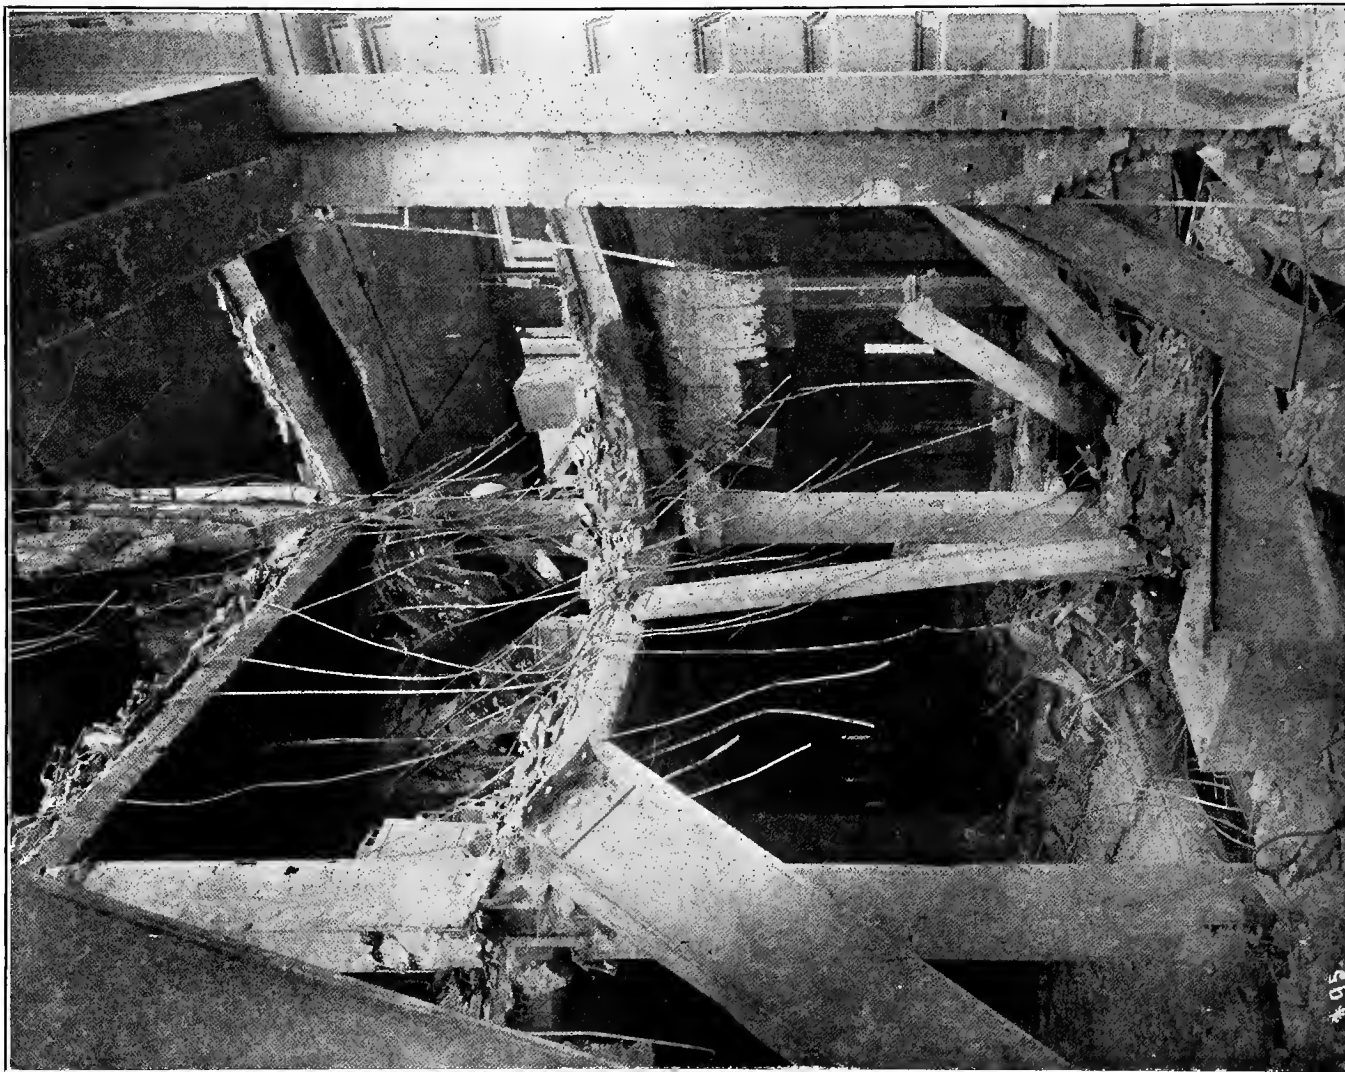
RIALTO BUILDING. Basement Story. Showing a buckled column under the wrecked portion on the New Montgomery Street side. Falling *débris*, sufficiently heavy to break down a section of the flooring, only cracked the soffit protection, which is still adhering to the beams.

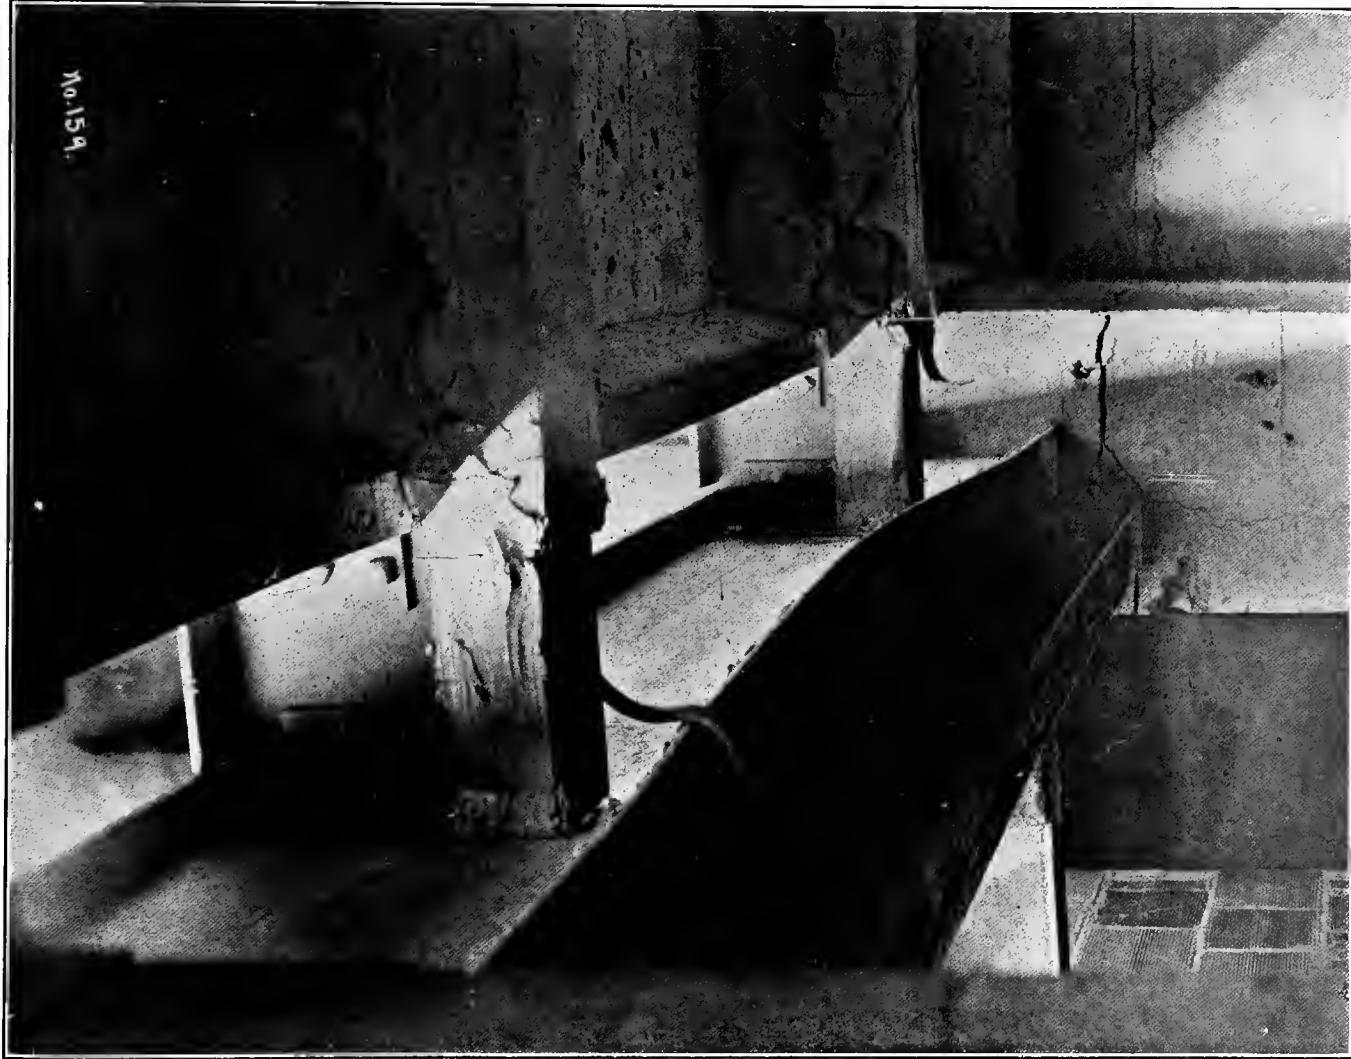
RIALTO BUILDING. Basement Story. Showing the unprotected steel at the building line where the vents were carried up underneath the first story show windows from the basement. The glass prisms of the sidewalk lights fused, the glass hanging in shreds as shown. Note also the earthquake damage to the supporting concrete pier. Compare this with the illustration on the opposite page.

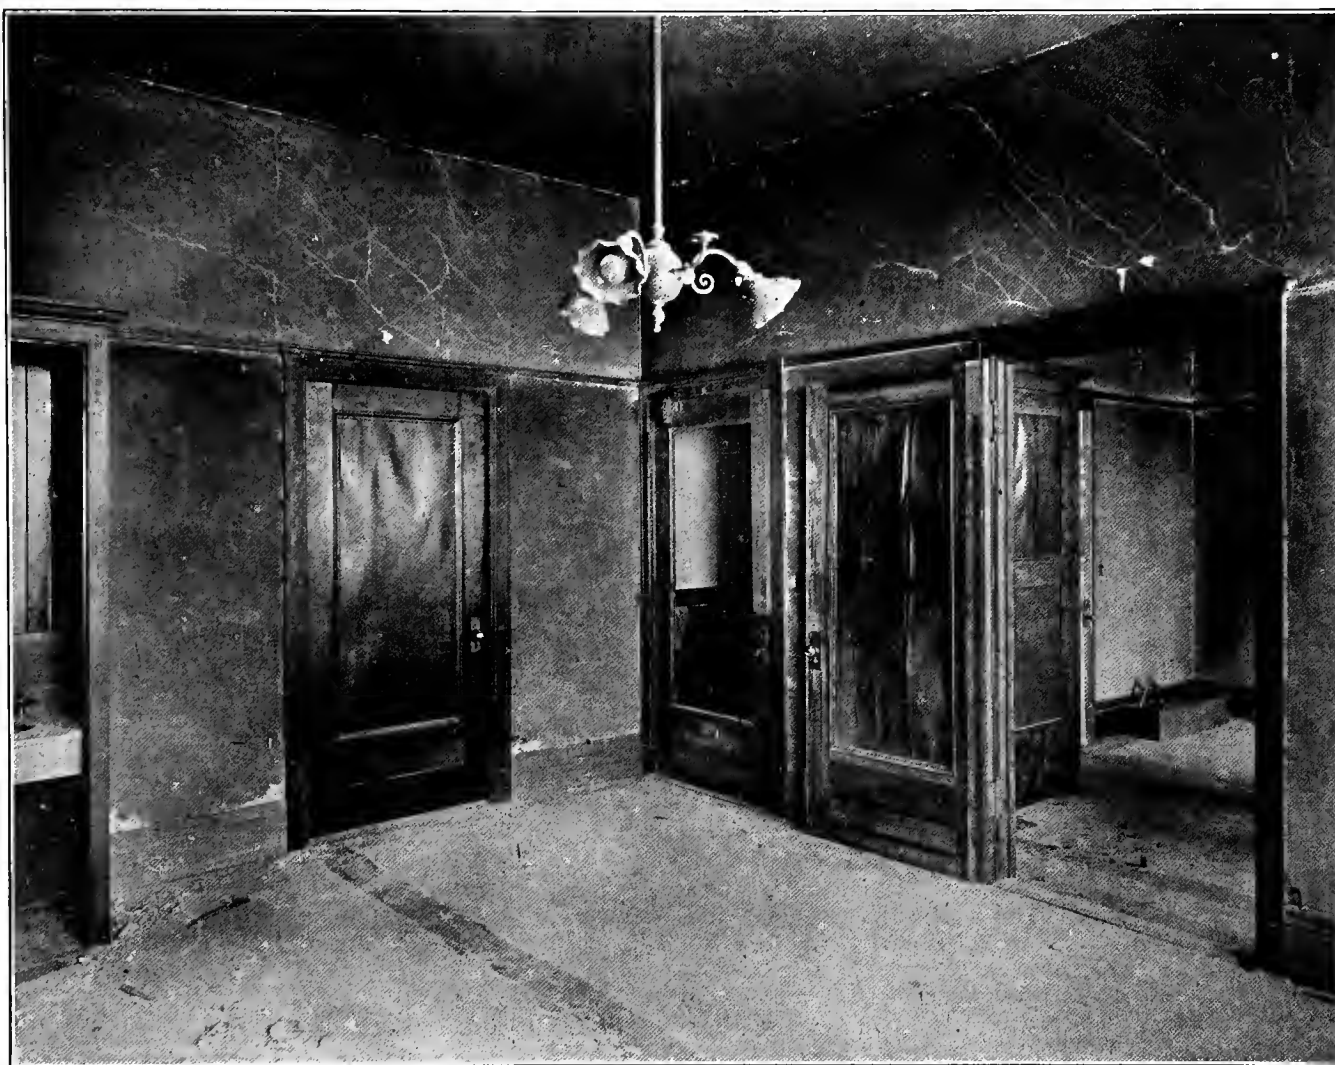
ATLAS BUILDING. Typical view of the lower stories. Metal lath and plaster partitions and ceilings, cement finished floors. The cracks in the plaster were caused by the earthquake and the dark color by smoke.

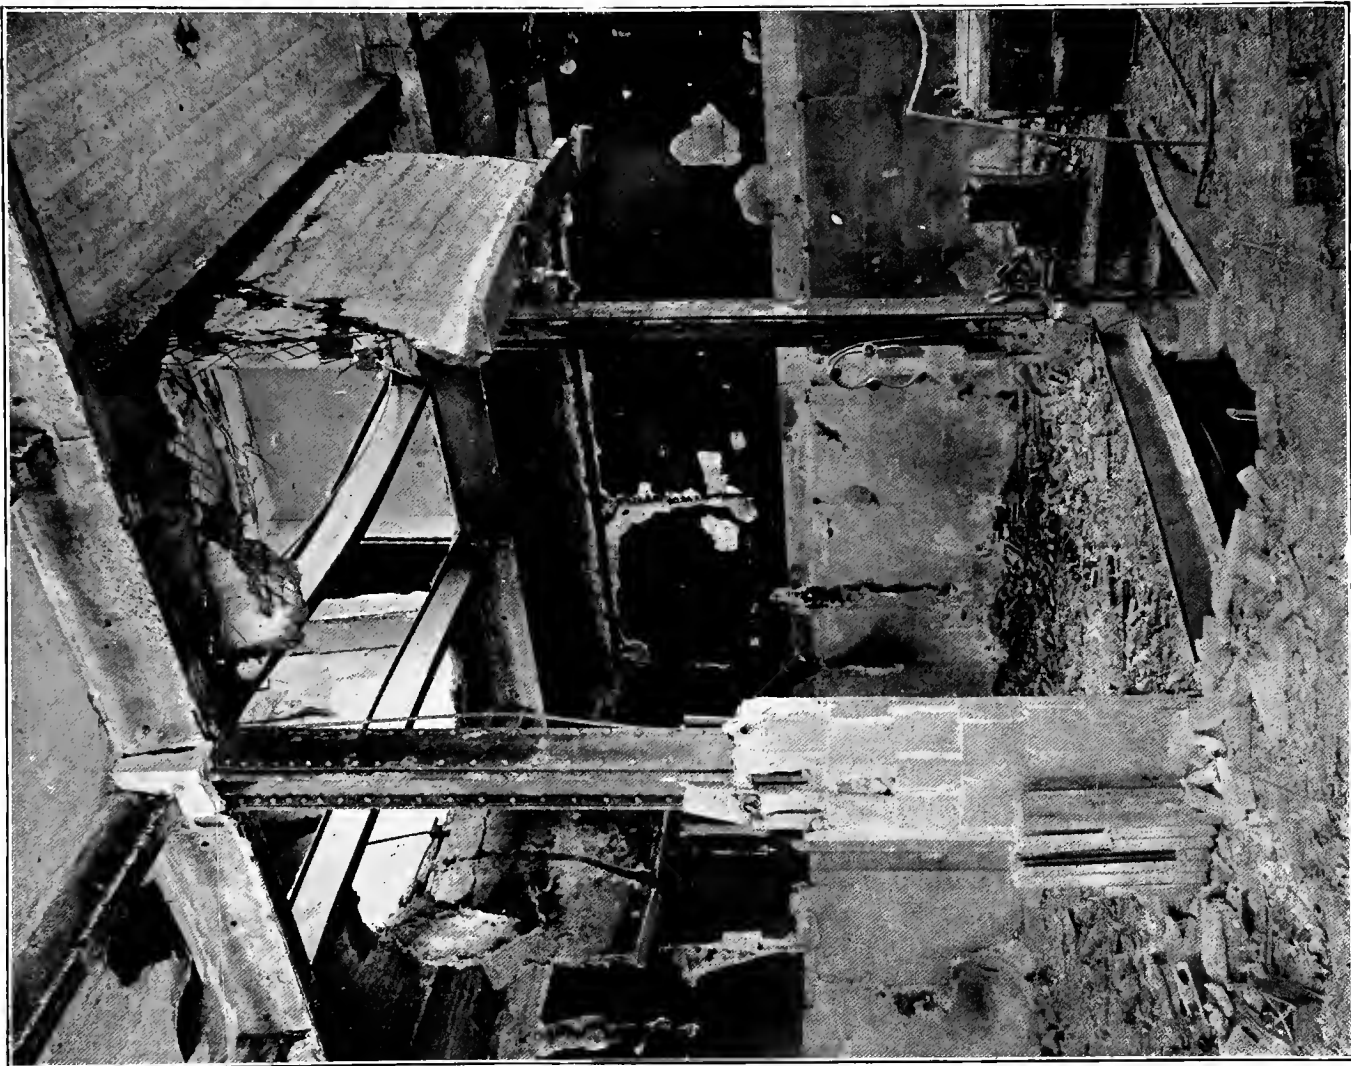
BULLOCK & JONES BUILDING. First Story. Showing the condition of the expanded metal concrete floors, and the hollow tile partitions and column covering. The expanded metal lath and plaster partition around the elevator shaft is standing, but has deflected out of plumb. The Cutler mail chute is bulged on account of the expansion due to the heat. The opening through the second floor at the upper right hand is the same shown in the succeeding illustration.

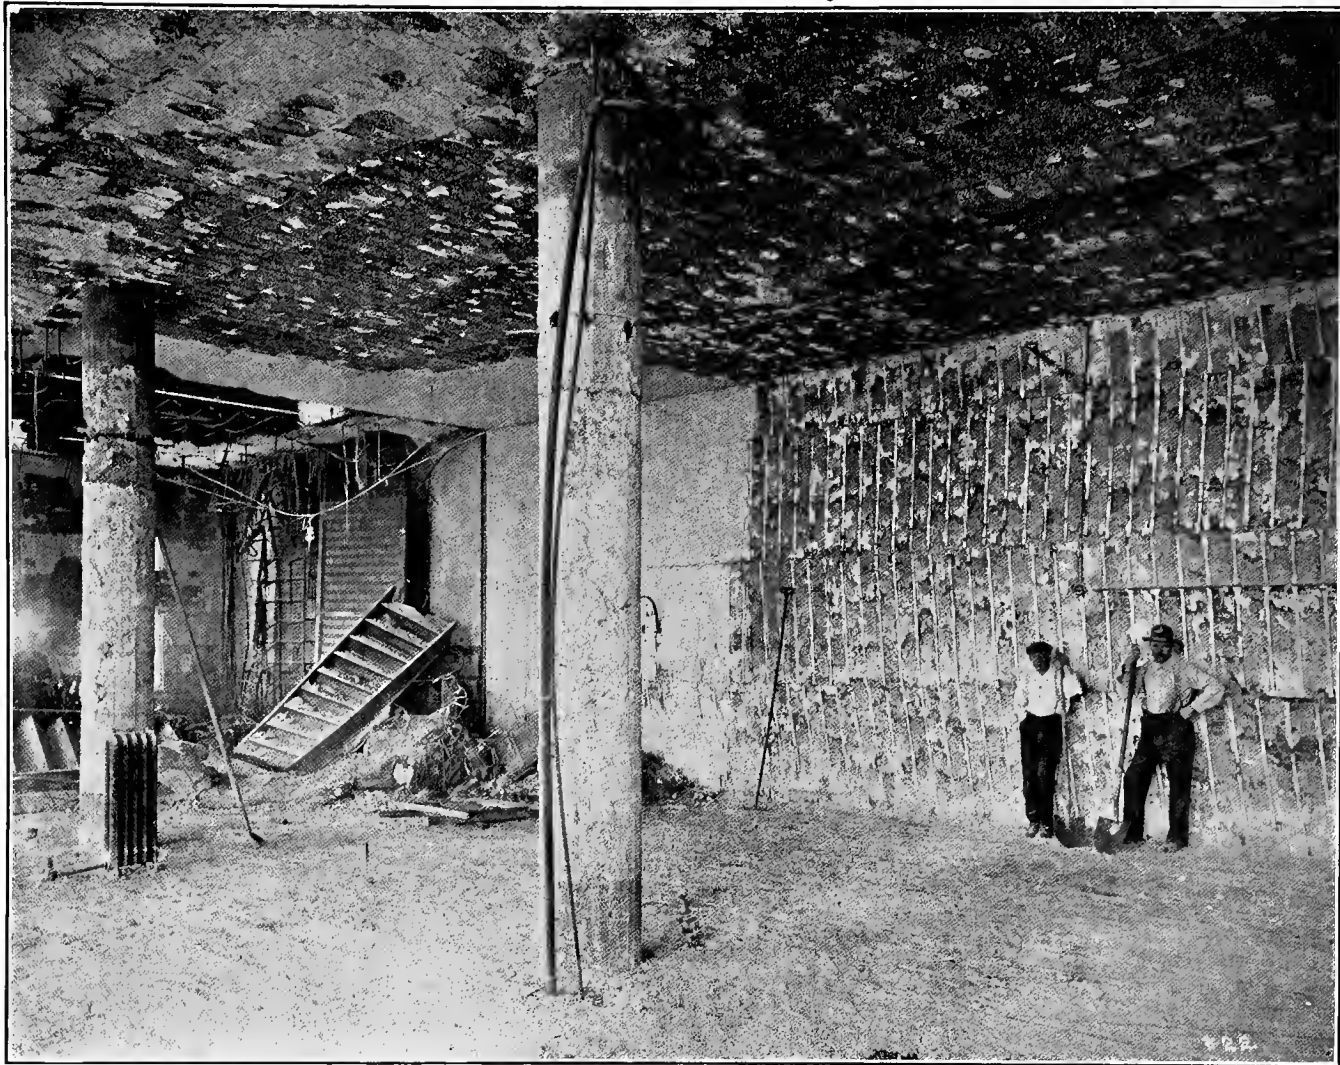
PACIFIC STATES TEL. & TEL. CO.'S Main Office. Fourth Story. Showing the typical condition of the Rocbling concrete floors, wire lath and plastered ceilings, wire wall furring and concrete column protection. The photograph was taken after the repair work had started and some of the plaster had been removed. This story was subjected to a severe fire, particularly around the cable rack well in the rear corner. The intense fire at this point spalled the brick wall and caused the failure of the cast-iron and metal tread stairway.

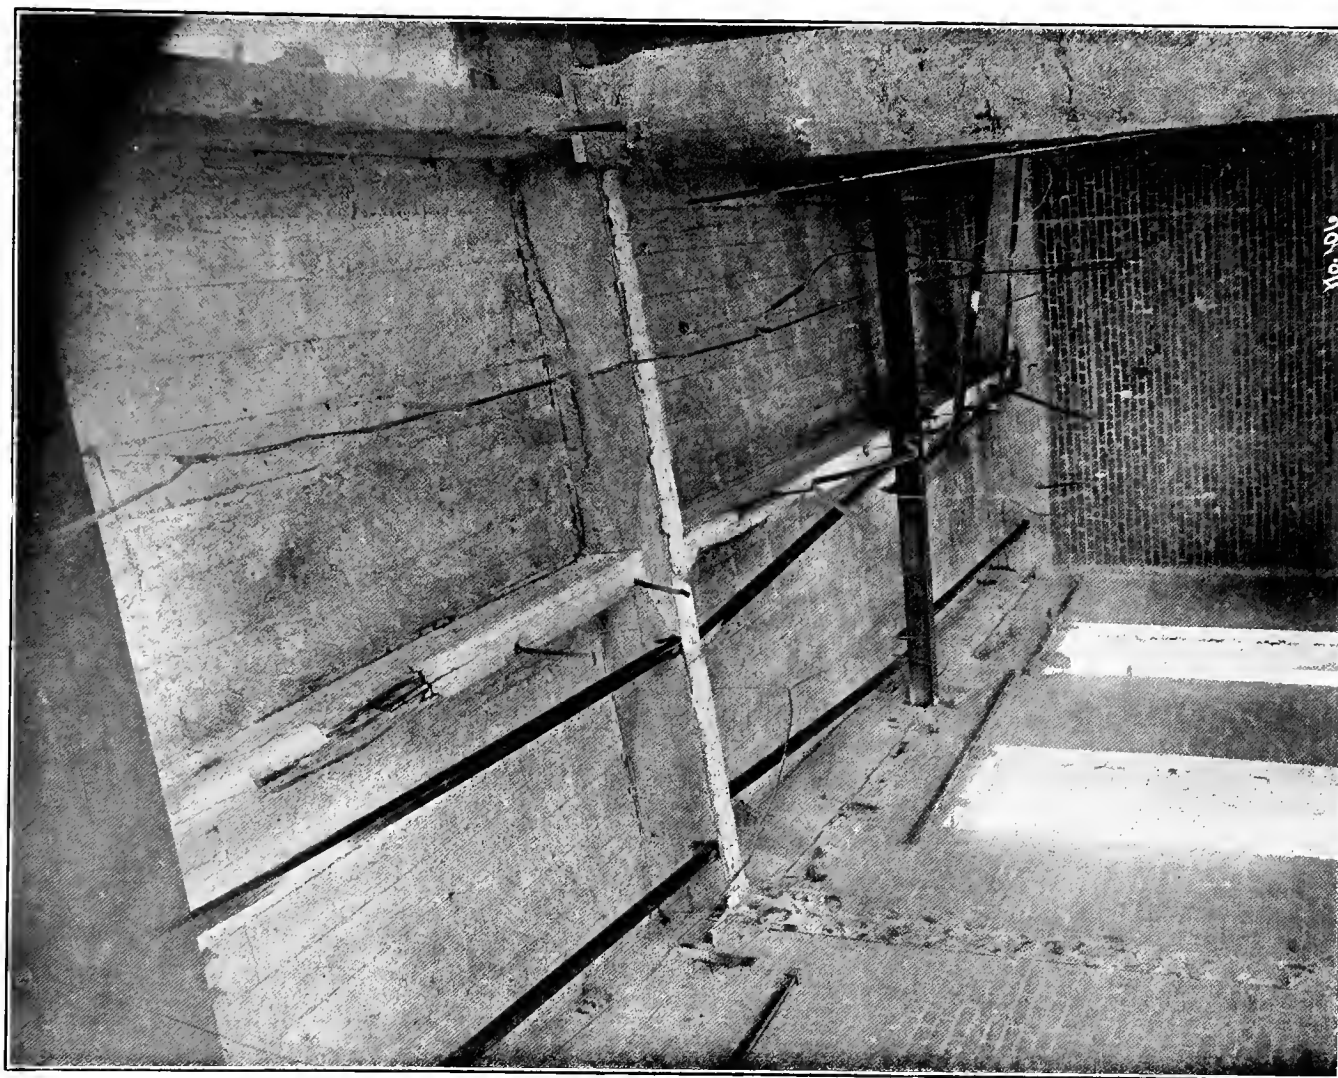
Fig. 396

PACIFIC STATES TEL. & TEL. CO.'S Main Office. Showing the partial failure of the reinforced concrete beams supporting the roof, which were damaged by fire. The photograph was taken after the temporary shoring had been put in place.

The damaged reinforced concrete beams in the roof tier will require renewal. The building is otherwise structurally uninjured and can be repaired without difficulty.

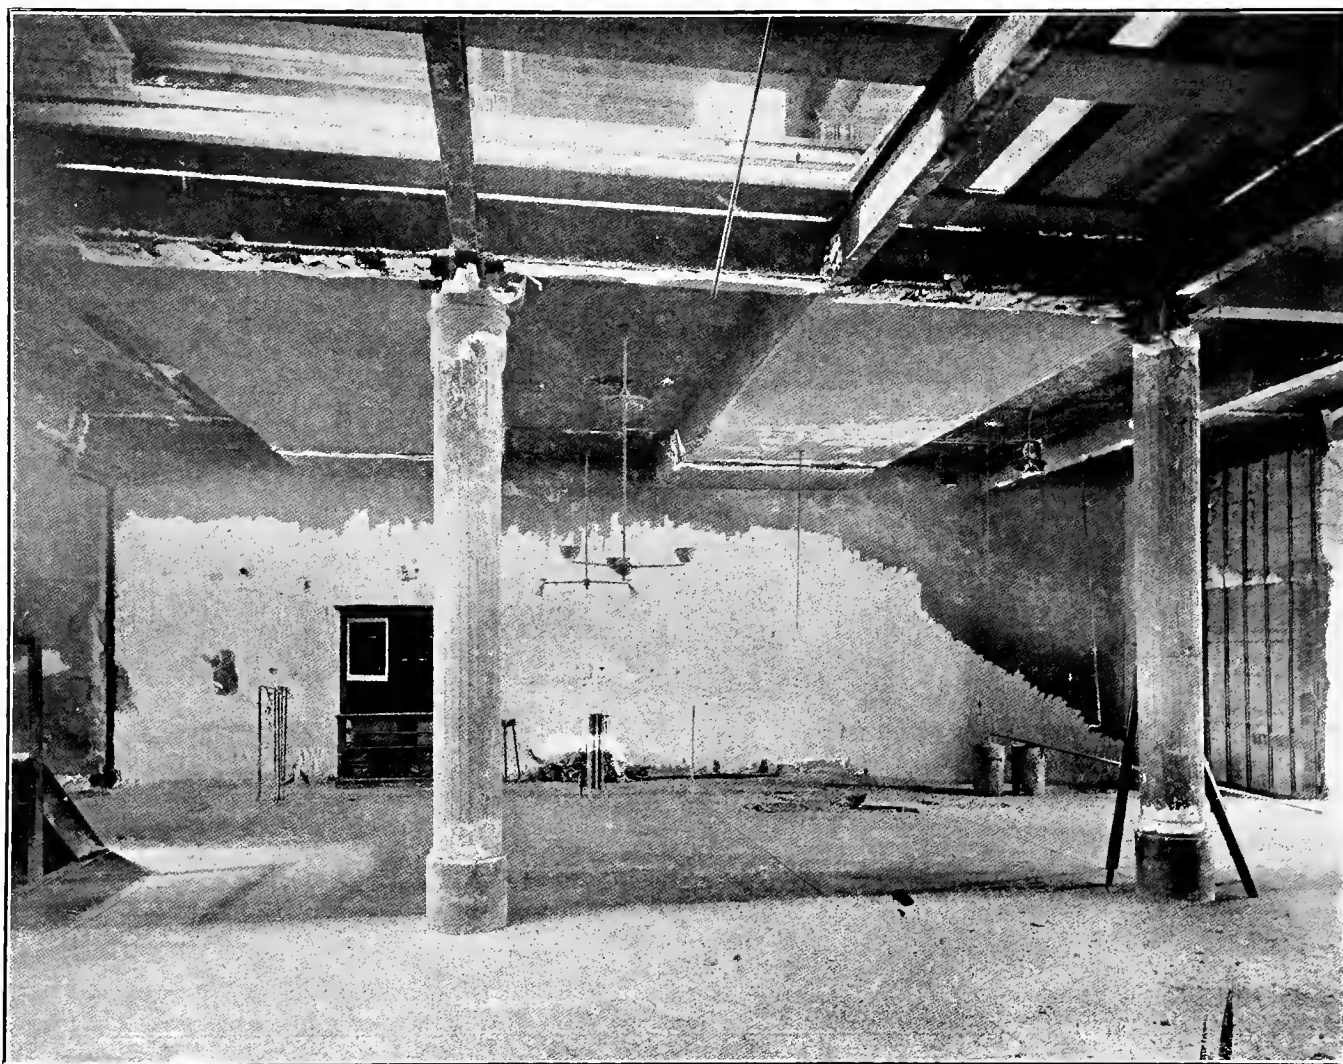
PACIFIC STATES TEL. & TEL. CO.'S East Office. Showing the typical condition of the concrete column protection and the damage to the cast plaster ornamental caps. The concrete protection should not have been omitted where the caps were placed. The photograph was taken after repairs had been begun.

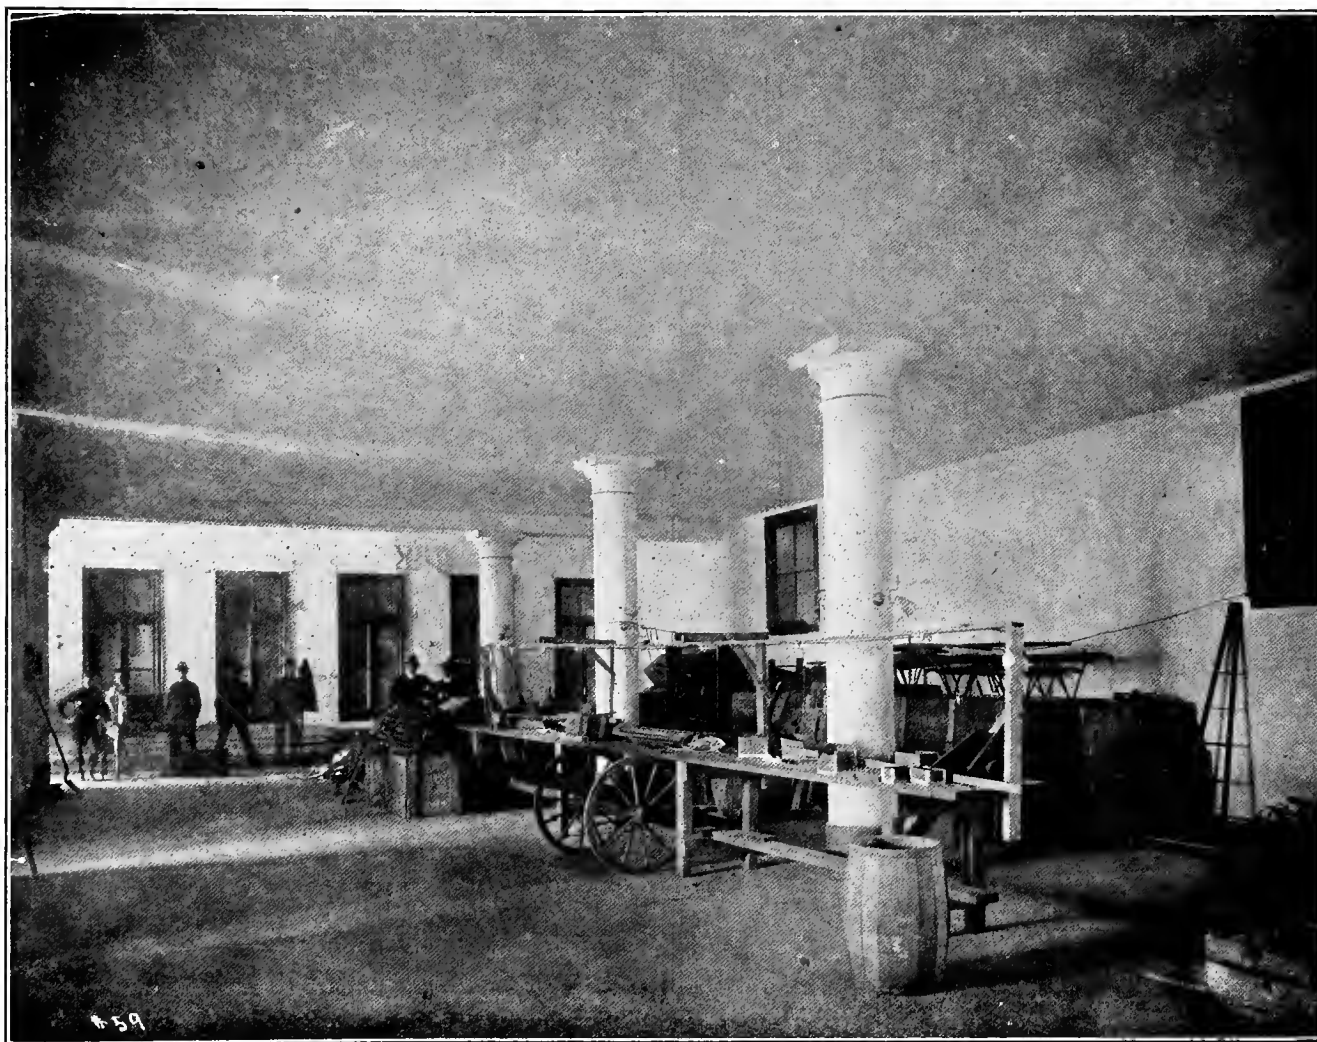
This building was but slightly damaged by the fire, most of the injury sustained by it being caused by the earthquake. The artificial stone base and buff terra cotta brick are practically uninjured. The white cement plaster finish of the upper stories is badly disfigured by earthquake cracks. The south wall at the southwest corner has cracked loose from the west wall, from the top to the bottom. The east and west walls are shaken and racked so that sections of the southeast and northwest corners fell out. Portions of the roof arches being unsupported after the walls fell out, dropped down into a vertical position and are supported by the steel beams adjacent to the walls. The north

PACIFIC STATES TEL. & TEL. CO.'S South Office, 74 and 76 West Mission Street. The façades consist of gray artificial stone to the water table, buff terra cotta brick to half the height of the first story and white cement finish on common brick above. This building had a temporary wood roof supported by the fourth floor, it being intended to increase the height of the building later. The top of the side walls and the parapet walls were overthrown, and portions of the walls were cracked and badly damaged by the earthquake. The two lower stories were provided with metal-covered window frames and sash, with wire glazing, which successfully preserved the contents of these stories. Fire was communicated to the top story through the window openings, which were finished with ordinary wood frames and sash. There was a large amount of expensive equipment and combustible contents in this story, which produced an intensely hot fire. The steel framing and the Roebling concrete floors and column protection remain in first-class condition.

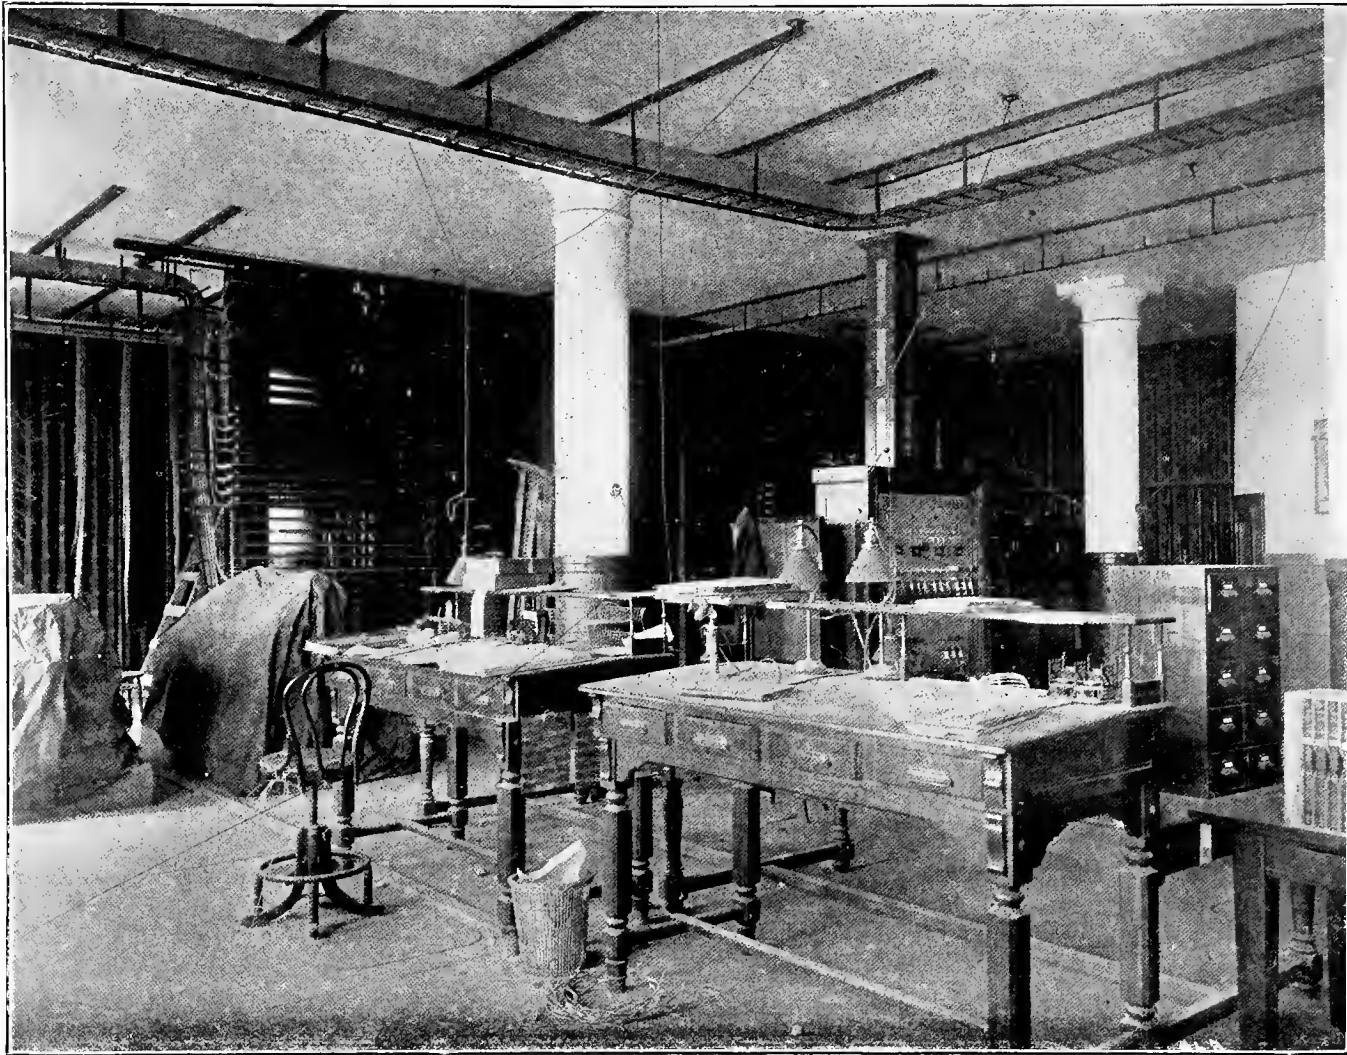
PACIFIC STATES TEL. & TEL. CO.'S South Office. First Story. Showing the condition of the interior, which sustained no fire damage. Note the earthquake cracks and damage to the plaster work in the rear. Everything combustible in the upper story of this building was consumed.
